**Oakland Piedmont Avenue Library  
86 Echo Ave  
Oakland, CA 94611**

## **Piedmont Avenue Library – Feasibility Study**

### **Facility Conditions Assessment Executive Summary**

**February 22, 2025**

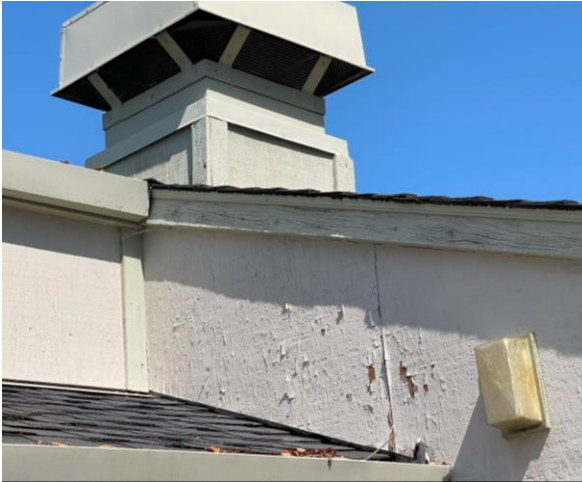
Exterior cladding is decayed. Paint is peeling.

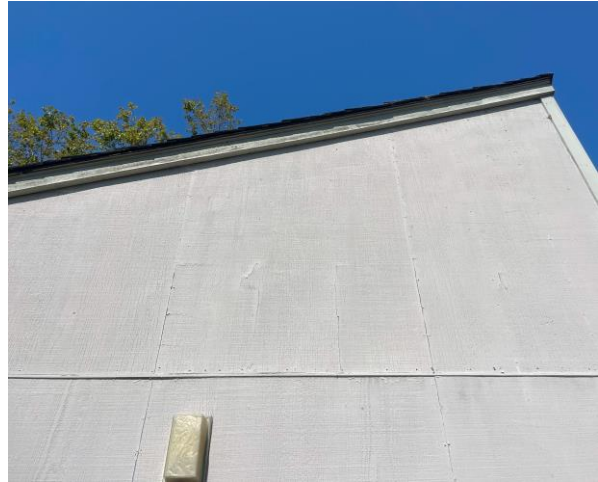
Unsealed joints and cracks at cladding.

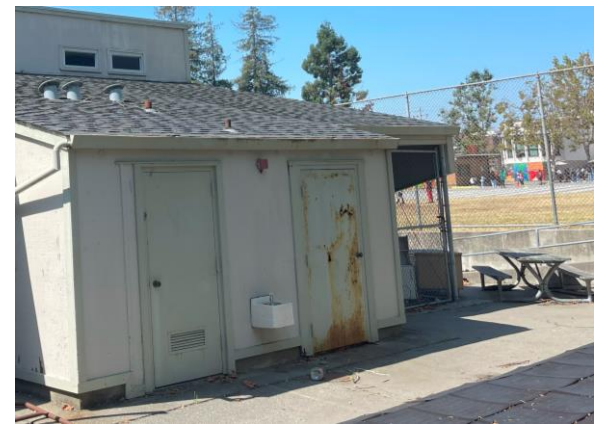
Toy storage door is rusted.  
Drinking fountain is non code-compliant.

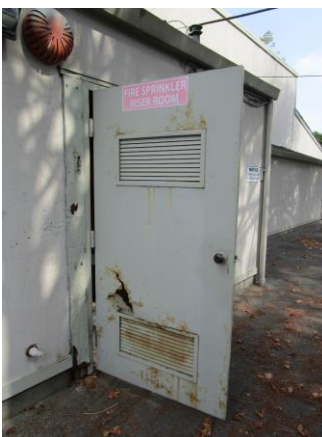
Utility closet door is rusted. Wood trim is decayed.

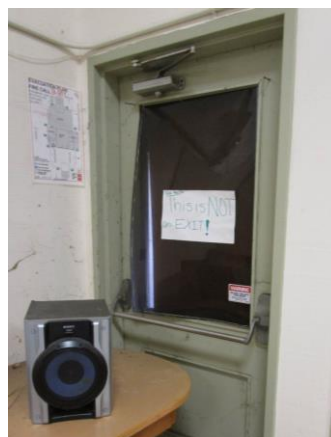
Damaged vision panel.

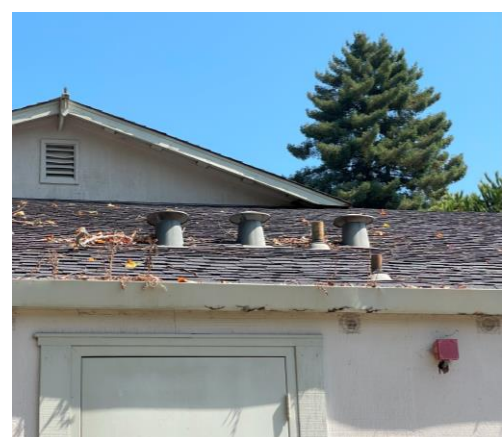
Rusted metal gutter at steep-slope roof.

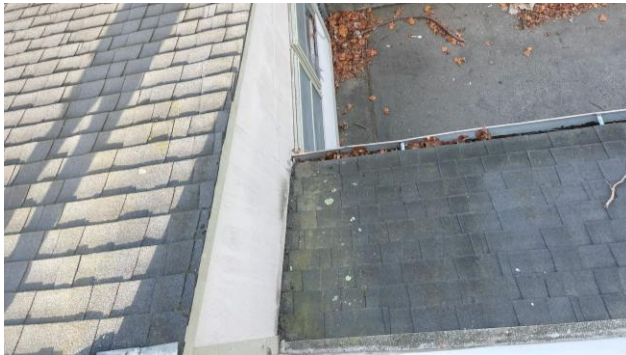
Organic growth on the asphalt shingles.  
Roofing has reached end of serviceable life.

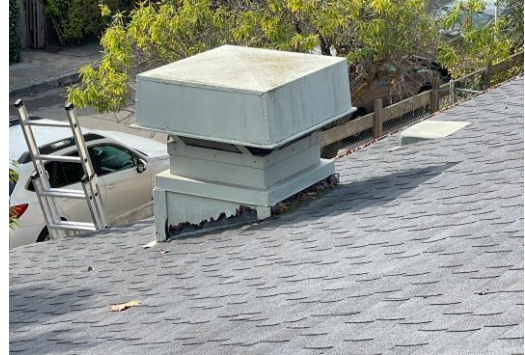
Wood decay at roof curb cladding with  
insufficient clearance to roofing.

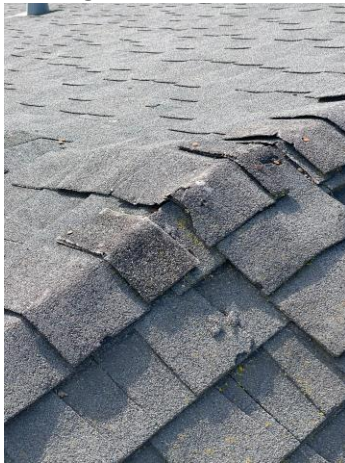
Missing shingles at ridge.

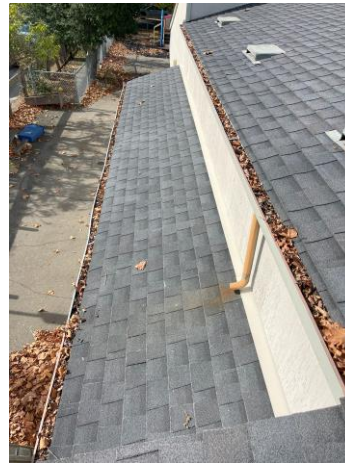
No screen at gutters.  
Rusted downspout

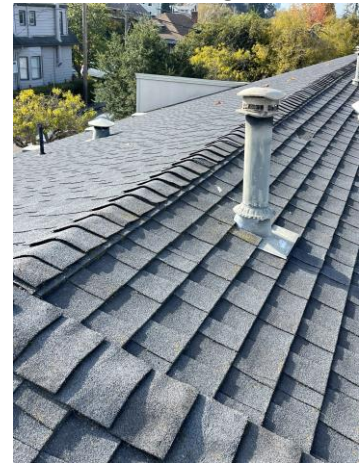
No roof vents at uninsulated  
roof.

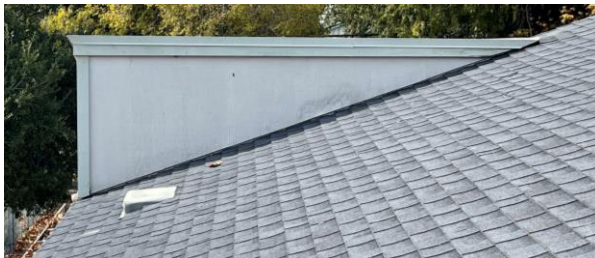
No clearance at base of cladding to roof transition.

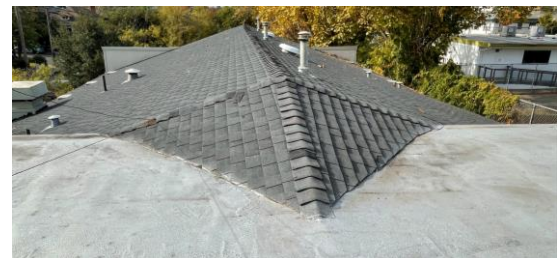
No valley flashing at transition to BUR.

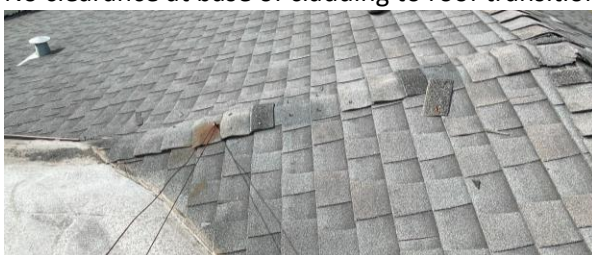
Damaged and missing asphalt shingles at ridge.  
Exposed roofing nails.

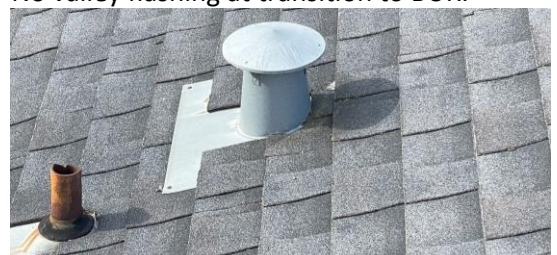
Exposed roofing nails at metal flashing.  
Rusted pipe penetration.

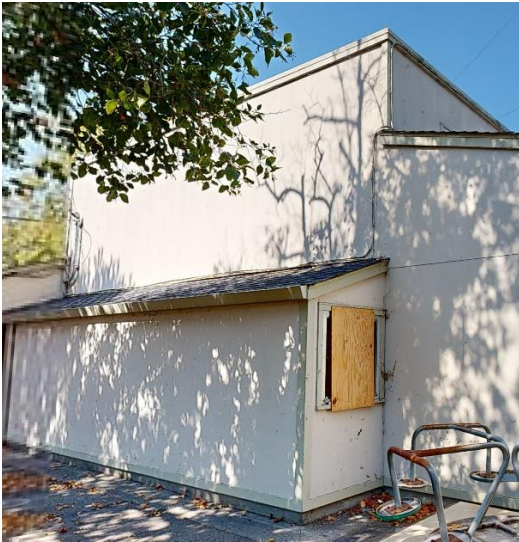
High low-slope built-up roof & damaged window glazing.

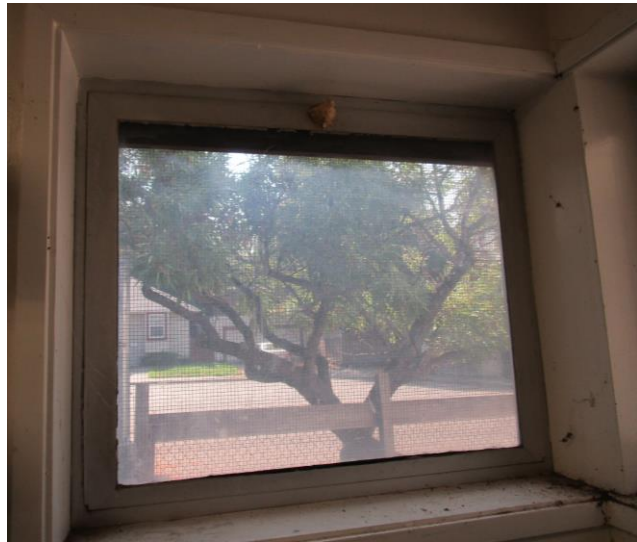
Single-glazed window is not operable.  
Glazing gasket must be replaced.

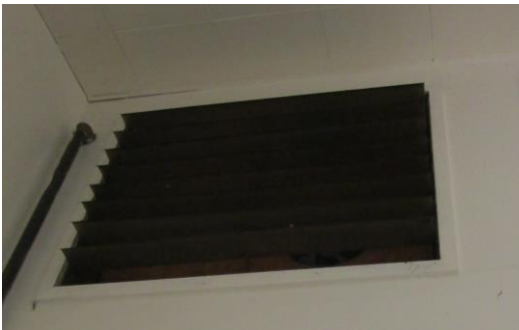
Ductwork terminates in Jalousie window.

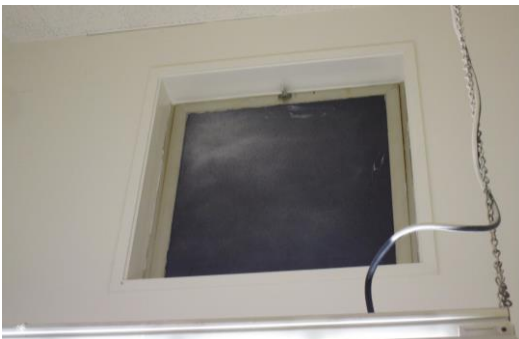
Clerestory window to attic is still in place.

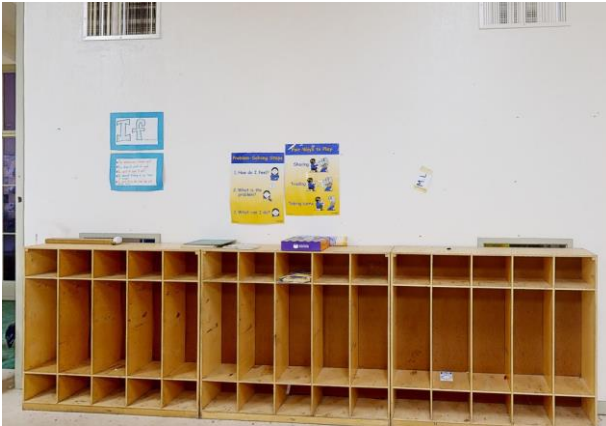
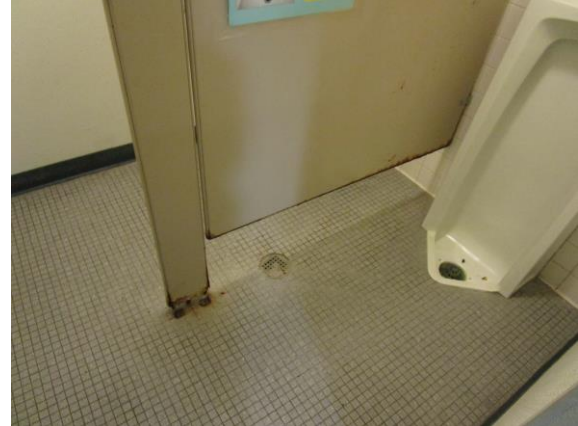
Vinyl covering on classroom wall behind work area. Rusty toilet compartment & dated urinal. Casework does not suit the needs of the library.

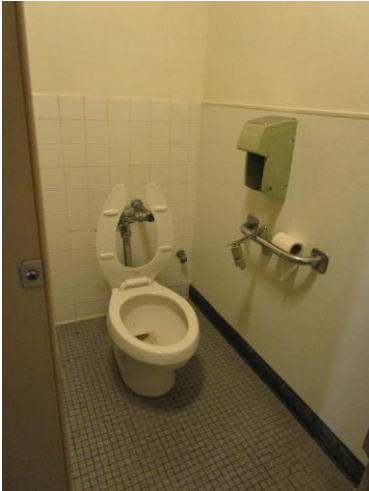
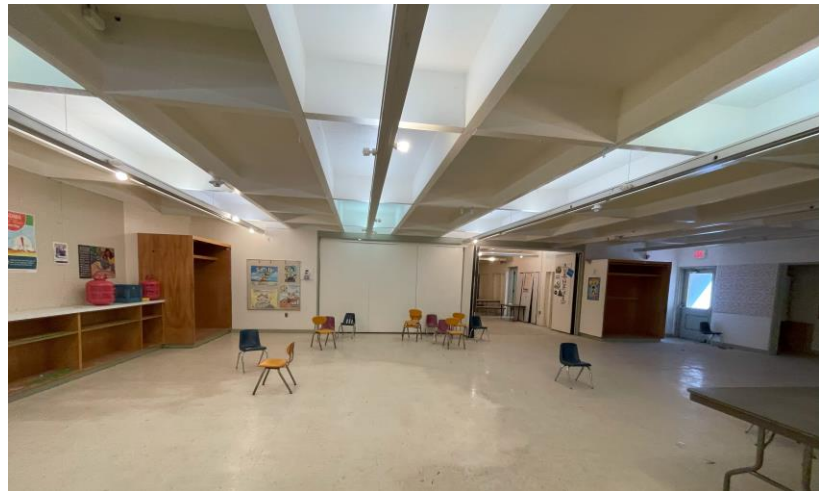
Interior finishes in restroom are dated and inconsistent. Wood coffer ceilings in classroom. Skylights have been removed.

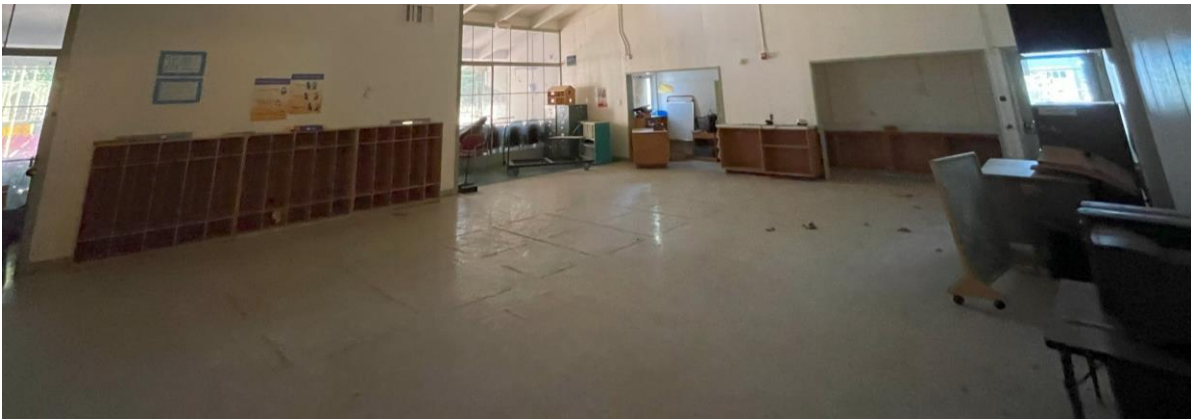
Classroom vinyl flooring is dated and failing.

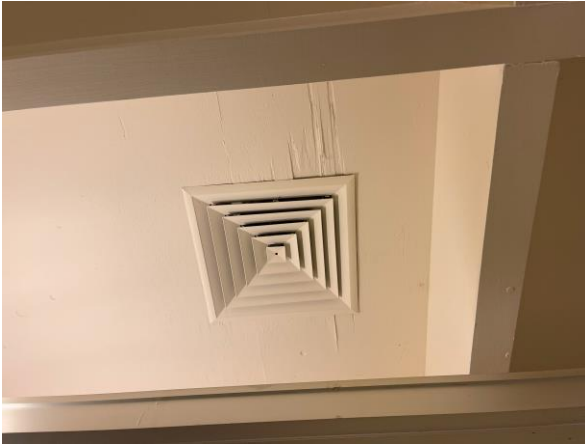
Damaged roof sheathing should be replaced.  
Roofing above should be patched.

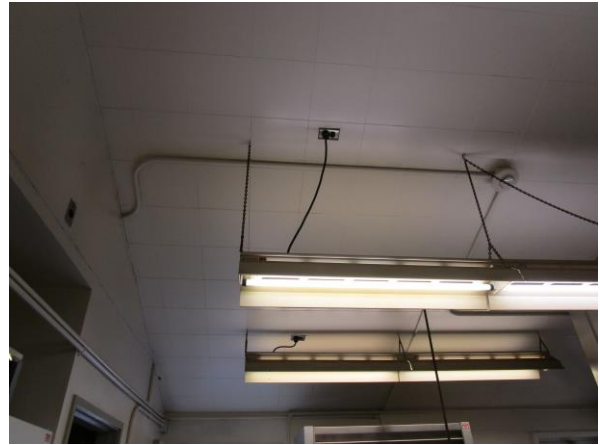
Kitchen sloped glue-on acoustical ceiling tile.  
Light fixtures are dated.

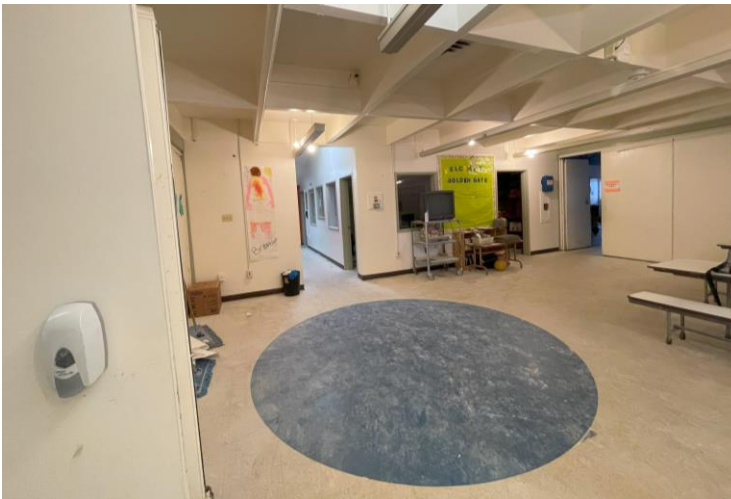
Vinyl flooring in dining area is worn out.

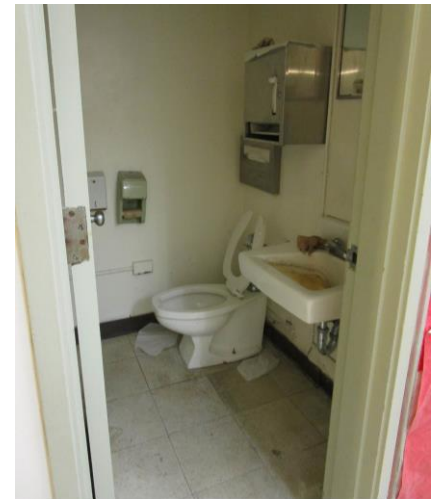
Staff restroom is under-sized.  
Vinyl flooring is dated and failing.

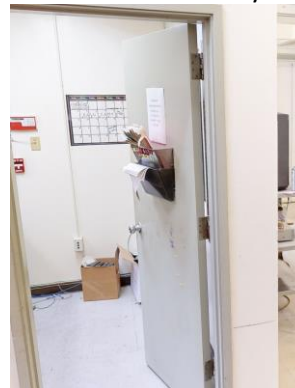
Rusted door hinges at  
office. Repaint door.

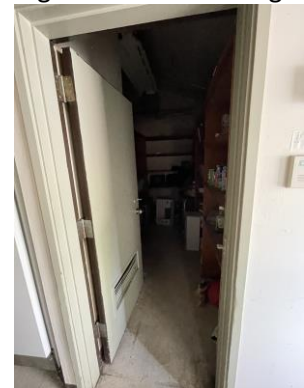
Kitchen storage door  
Door must be repainted.

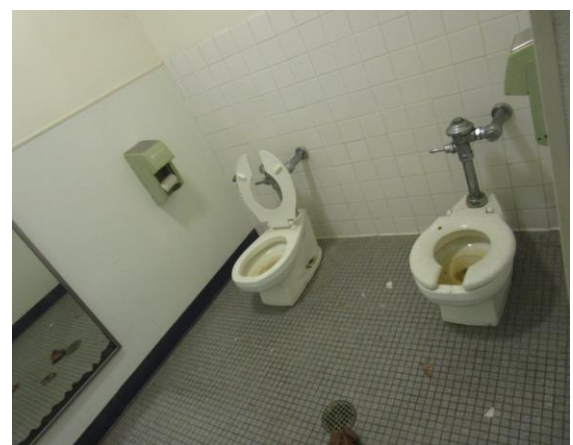
Students restroom with dated fixtures.

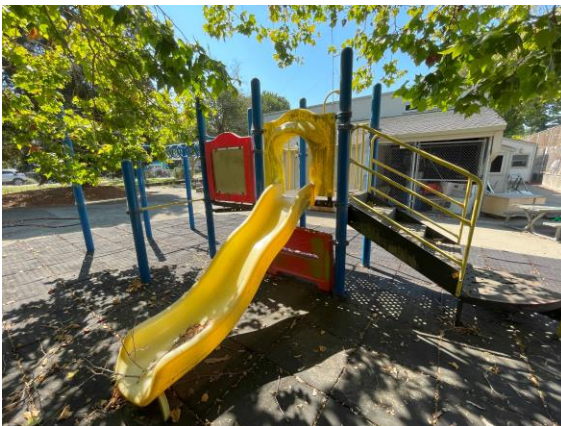
Play structure with old surfacing.

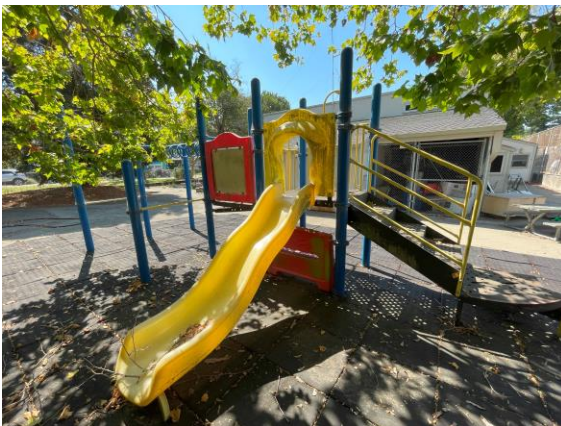
Play structure with old surfacing.
